INDOOR AIR QUALITY ASSESSMENT

**City of Brockton
Department of Weights and Measures
53 Meadowbrook Road
Brockton, MA**

Prepared by:
Massachusetts Department of Public Health
Bureau of Environmental Health
Indoor Air Quality Program
June 2018

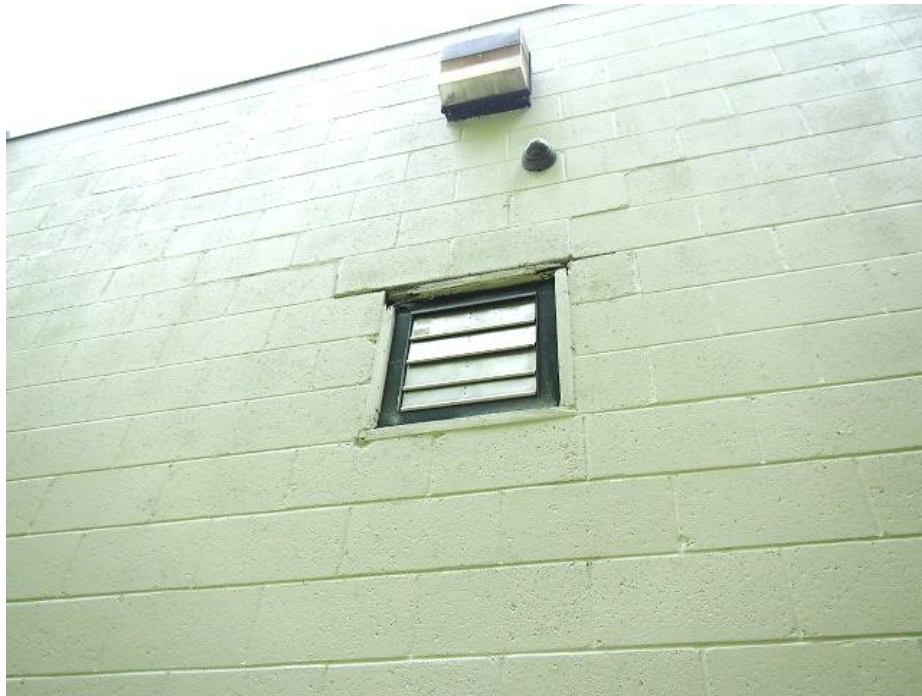
Picture 1

The large bay/garage had a wall-mounted exhaust fan installed in the west wall of the building that was deactivated and sealed at the time of the visit (Pictures 1 and 2). In order for an exhaust fan to properly function, a source of air is needed (makeup air). No make-up air vent for the exhaust fan could be identified, except for opening the garage/exterior doors, which would be inconvenient during freezing winter months.

Local exhaust fan in west wall

1. Unseal and activate the local exhaust fan to help remove odors and fumes as needed.
2. Install make-up air vent for local exhaust system, preferably in opposite wall.

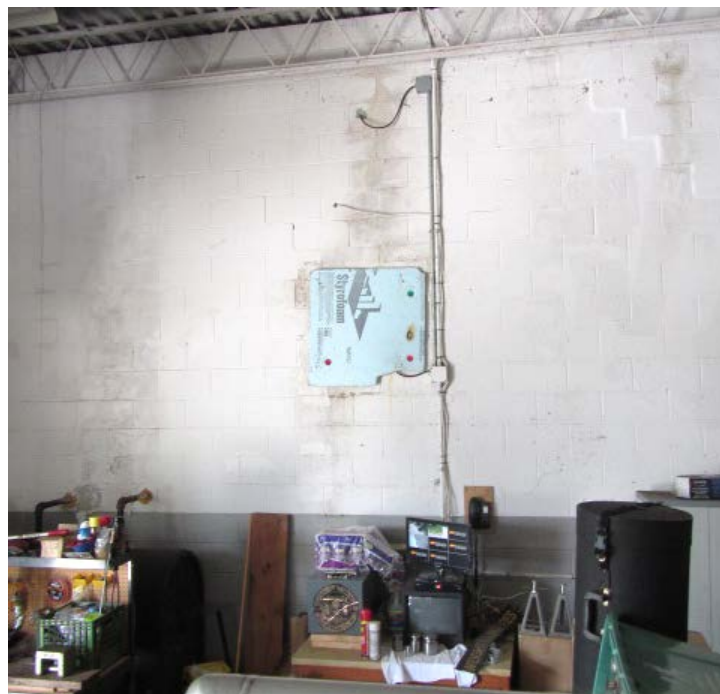
Picture 2

Sealed local exhaust fan in west wall

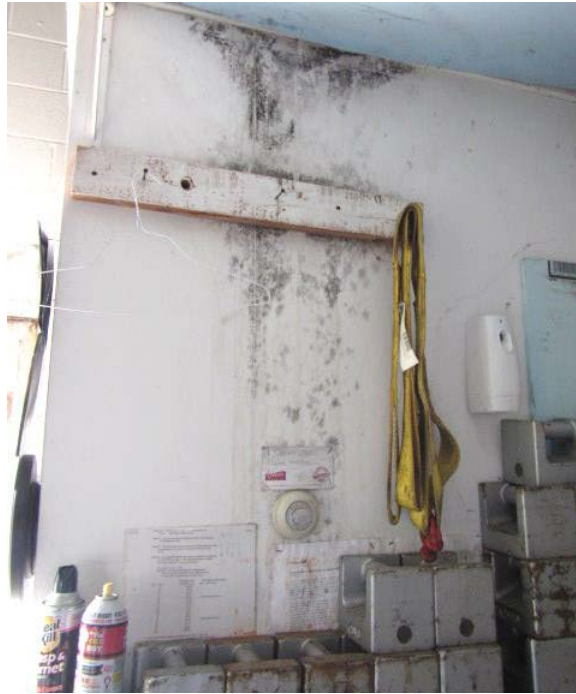
Picture 3

Chronic water damage and visible mold growth was observed on gypsum wallboard (GW) (Picture 3) and on interior concrete walls (Pictures 4 through 9). Although the concrete itself is not a mold growth medium, the accumulated dirt/dust and debris on the surface of walls can be. The interior walls also showed severe signs of water penetration in the form of peeling paint and efflorescence. Efflorescence is a characteristic sign of water damage to building

Mold growth (dark staining) on gypsum wallboard

5. Remove/replace water-damaged/mold contaminated gypsum wallboard and ceiling tiles.
6. Remove and discard all water-damaged stored materials (e.g., paper/cardboard).

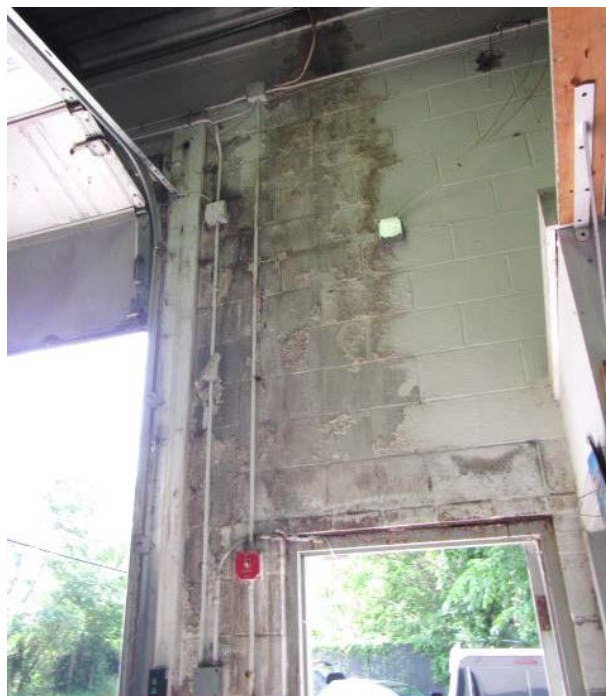
Picture 4

Water-damaged walls

3. Continue with plans to make roof/flashing repairs.
4. Once repairs are made, remove all items from building in order to properly clean/scrape/pressure wash peeling paint/damaged walls and building interior. Ensure space is properly dried prior to reoccupancy.

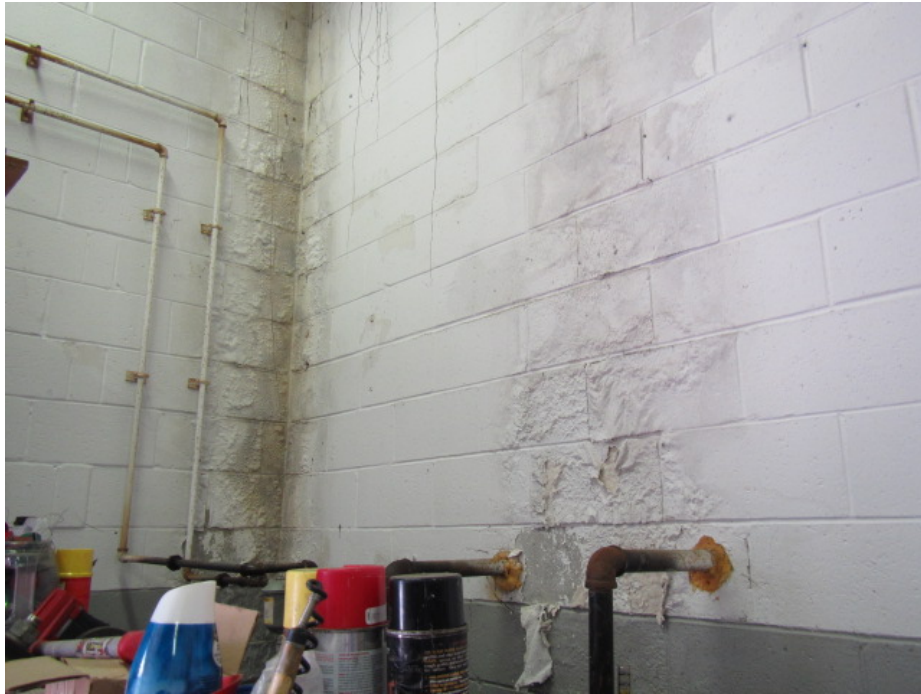
Picture 5

Water-damaged walls

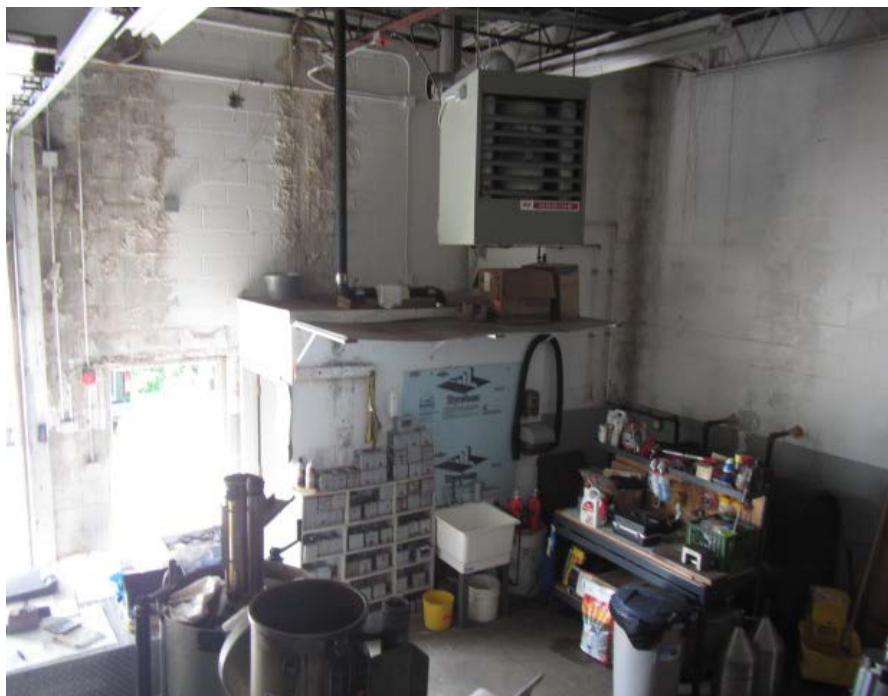
Picture 6

Water-damaged walls

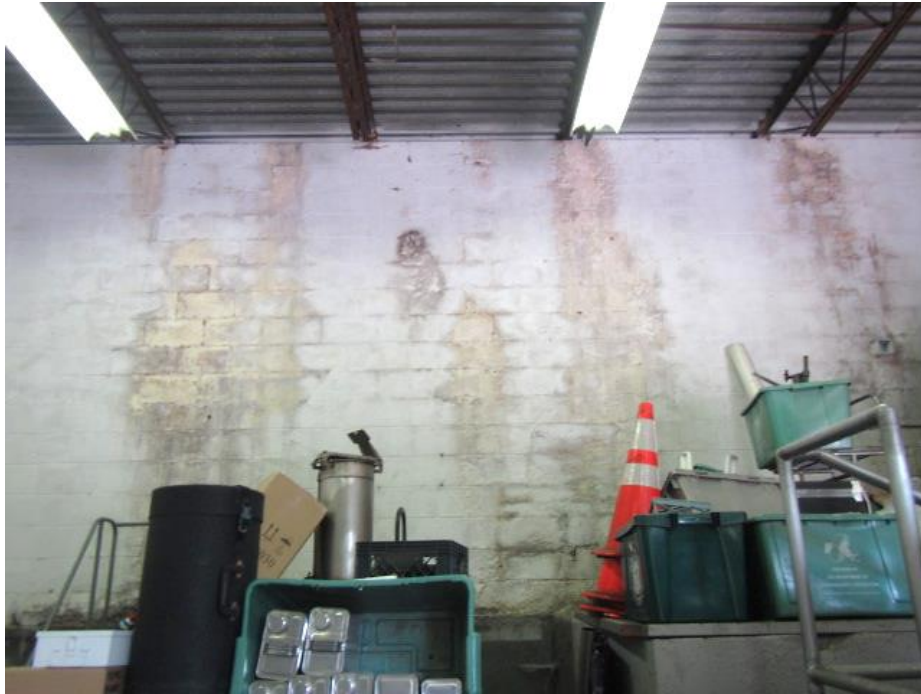
Picture 7

Water-damaged walls

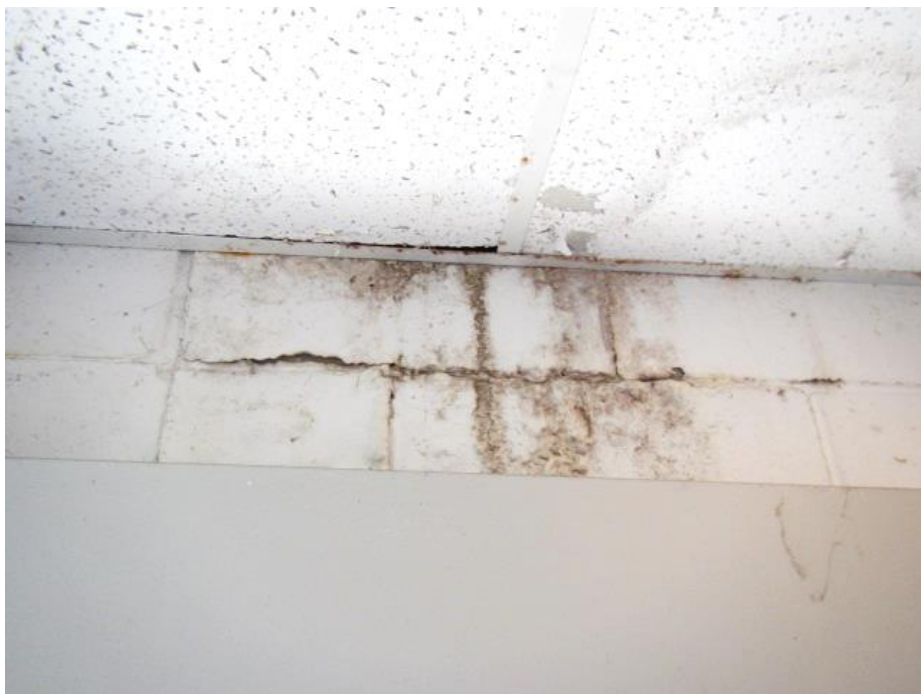
Picture 8

Water-damaged walls

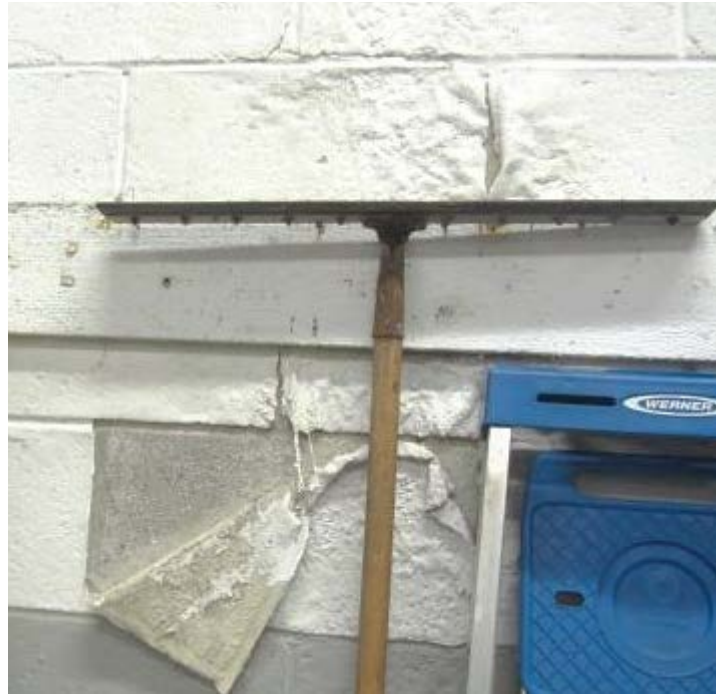
Picture 9

Water-damaged walls

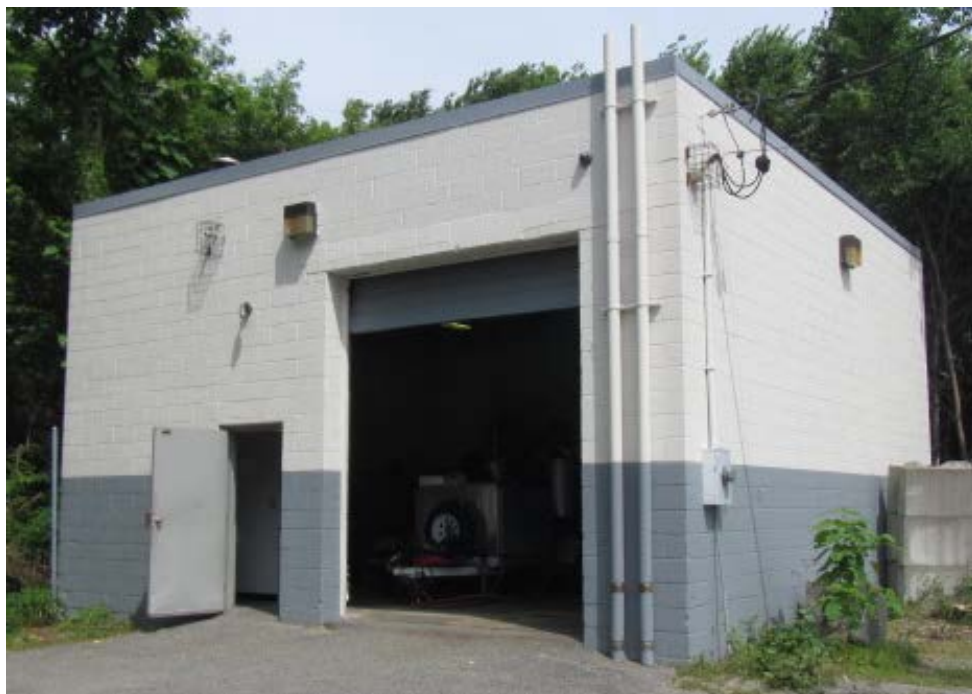
Picture 10

materials such as brick, mortar, or plaster. As moisture penetrates and works its way through mortar around brick, water-soluble compounds dissolve, creating a solution. As the solution moves to the surface of the brick or mortar, water evaporates, leaving behind white, powdery mineral deposits. This condition indicates that water from the exterior has penetrated into the building. When present, efflorescence can be readily cleaned. At the time of the assessment it was reported that the roof/flashing was slated for repairs within the next several weeks, which should reduce water penetration issues. In addition, the exterior of the building was recently painted (Picture 10).

Exterior of building recently painted

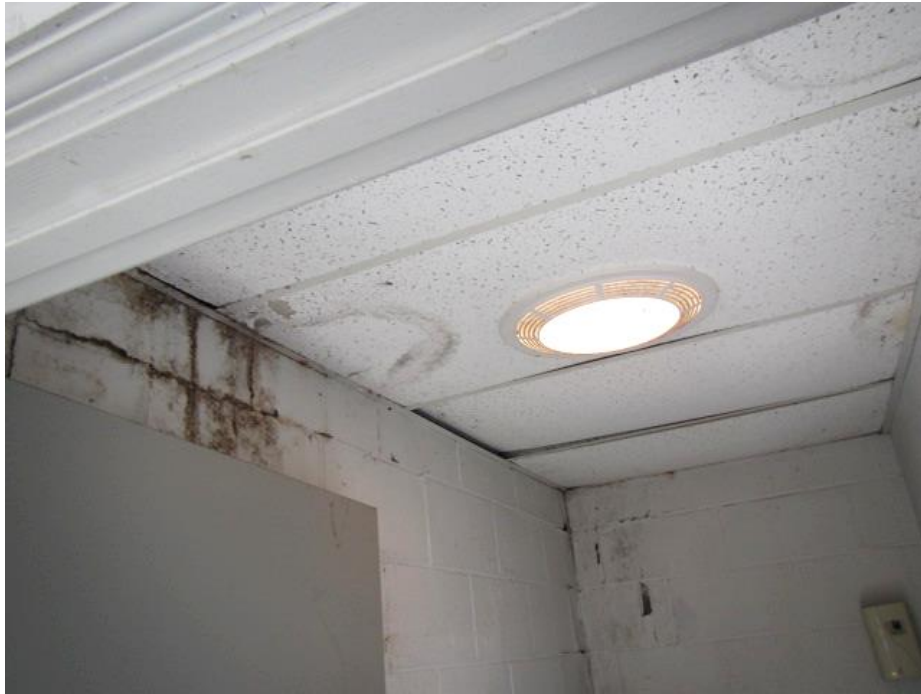
Picture 11

The bathroom also had water-damaged ceiling tiles (Picture 11). Stained or damaged ceiling tiles indicate roof or plumbing leaks. Tiles should be replaced once leaks are found and repaired.

Other conditions that can affect IAQ were observed during the assessment. The staff restroom has an exhaust fan that vents inside the building (Pictures 11 and 16). Restrooms should be properly vented to the outside to remove excess moisture and odors.

Water-damaged ceiling tiles and walls in bathroom, note exhaust vent/light

8. Consider providing dehumidifiers that self-drain to maintain humidity levels.
9. Ensure restroom exhaust is vented properly outside the building.
10. For buildings in New England, periods of low relative humidity during the winter are often unavoidable. Therefore, scrupulous cleaning practices should be adopted to minimize common indoor air contaminants whose irritant effects can be enhanced when

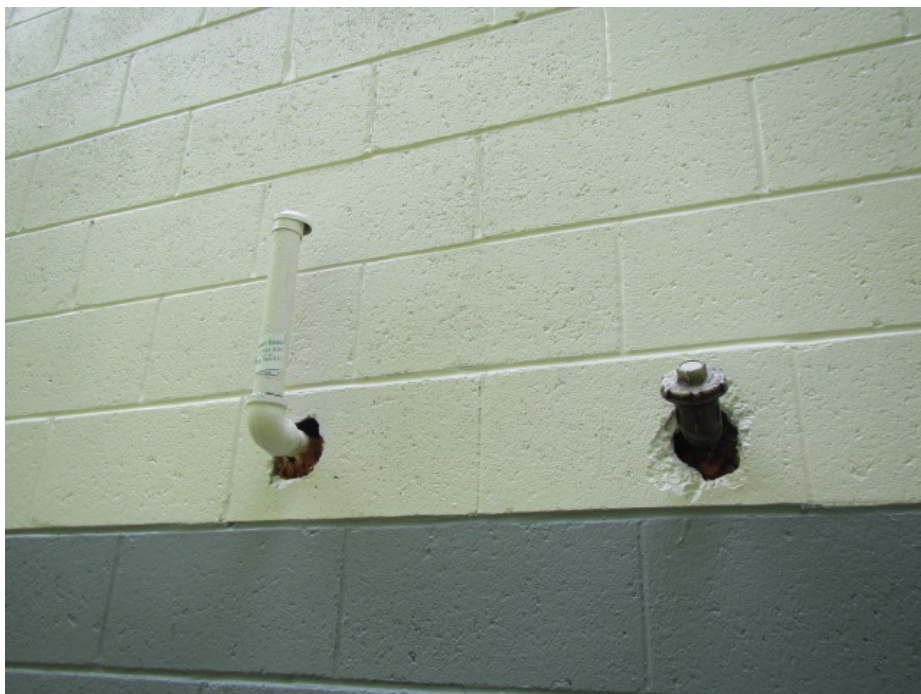
Picture 12

Open spaces were seen around utilities/pipes penetrating exterior walls and underneath the exterior door (Pictures 12 and 13). These breaches can provide pathways for drafts, moisture and/or pests into the building. It is also important to note that the space does not have any means to reduce/remove moisture (e.g., air conditioning, dehumidification); therefore any paper, cardboard or other porous materials would be subject to mold growth from elevated humidity conditions.

Spaces around utility pipes

7. Seal any holes/breaches/pathways (e.g., spaces under doors/exterior walls) to prevent drafts, moisture and pests from entering. Install weather-stripping on exterior and garage doors, if doors cannot be made tight to prevent drafts/moisture/pests, repair or consider replacing. Ensure tightness of doors by monitoring for light penetration and drafts around doorframes.

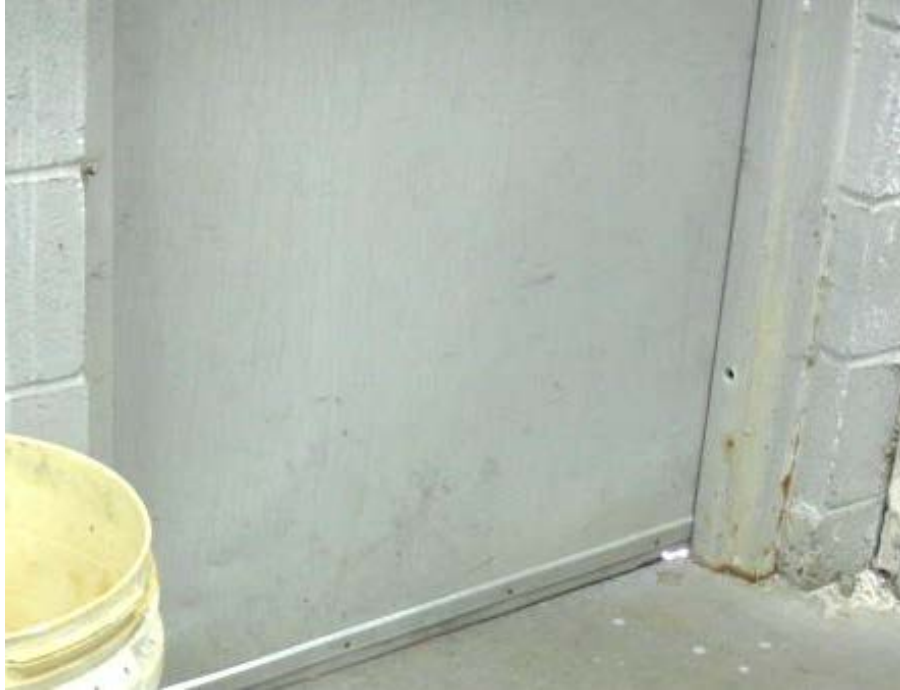
Picture 13

Light penetrating under exterior door

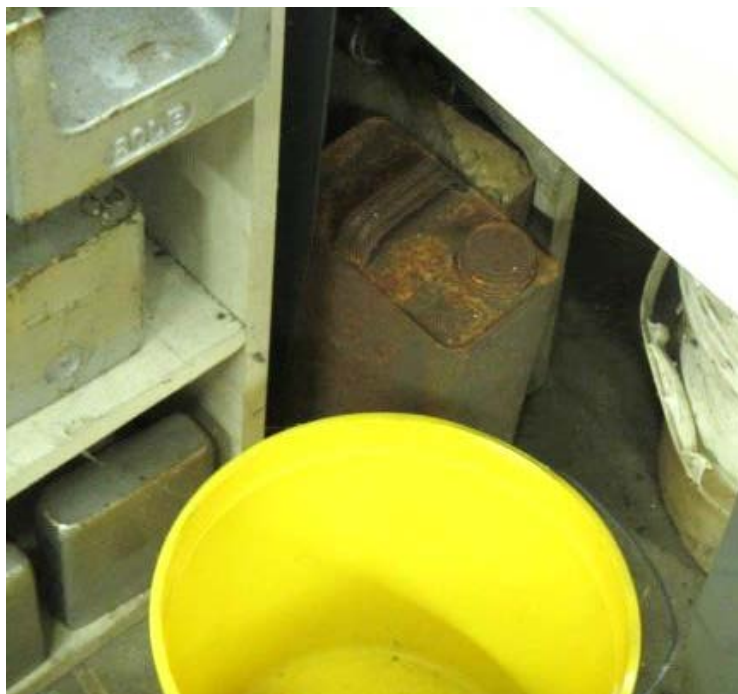
Picture 14

It is important to note that in this building, employees must work with various products that likely contain potentially hazardous materials e.g., (gasoline/oil and other unknown chemicals, Pictures 14 and 15) that are related to job function. For this reason, control of chemicals, proper protective equipment and proper ventilation, as well as emergency response information/procedures should be available. Staff should be trained in the safe handling of materials. As noted previously, the IAQ staff conducted air sampling for TVOCs using a photo ionization detector (PID), which identified measurable levels of TVOCs that were attributed to

Unknown chemical in corroded container under sink

11. Conduct a thorough chemical inventory of the space and discard any outdated/unwanted materials in accordance with local/state hazardous waste laws and regulations. Ensure remaining chemicals are stored in appropriate, intact, tightly-sealed, and properly-labeled containers.
12. Refer to resource manual and other related indoor air quality documents located on the MDPH's website for further building-wide evaluations and advice on maintaining public buildings. These documents are available at <http://mass.gov/dph/iaq>.

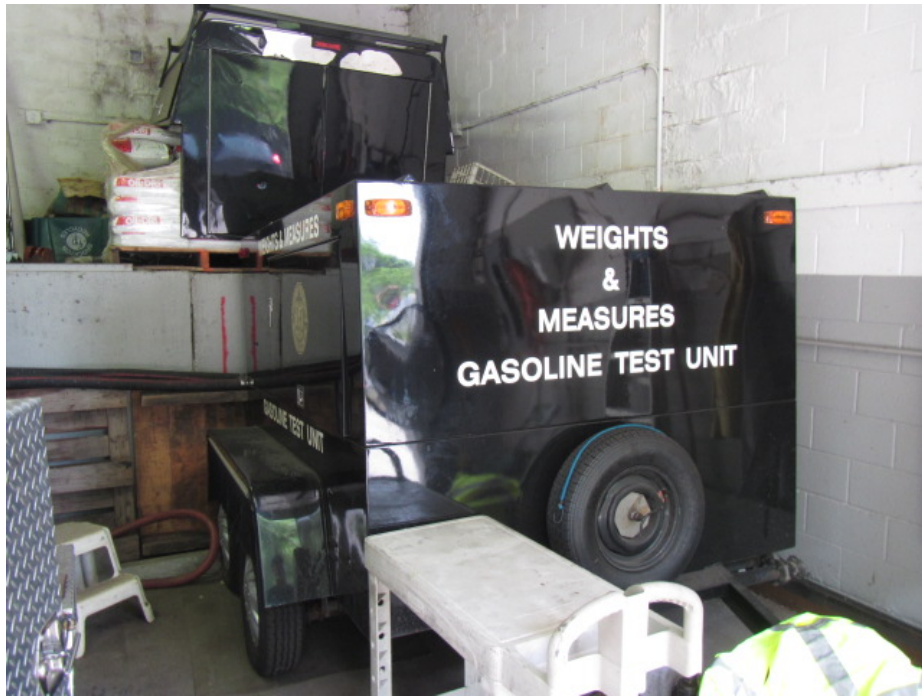
Picture 15

Gasoline test unit

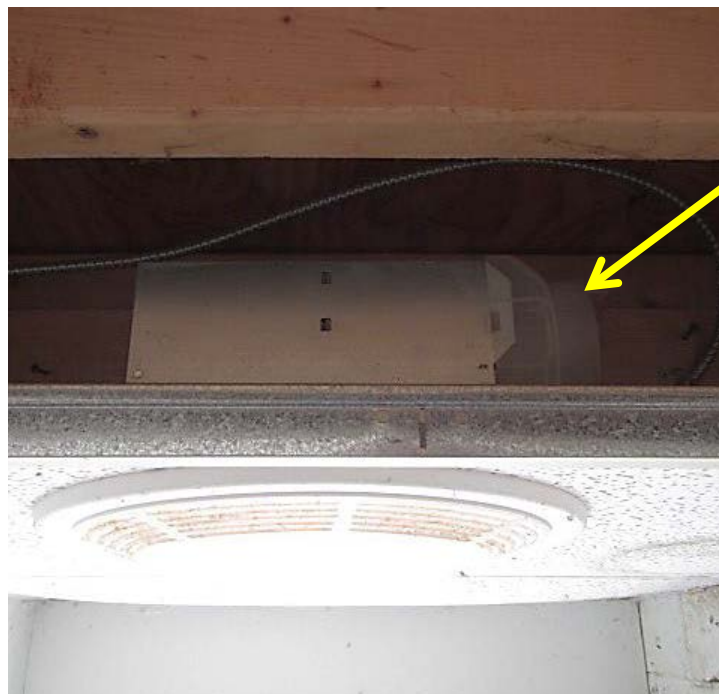
Picture 16

Terminus of restroom exhaust vent (arrow) emptying above ceiling
